The Locomotive

THE HARTFORD STEAM BOILER INSPECTION AND INSURANCE CO.

VOL. XXXIV.

INDEX TO VOL. XXXIV.—1922-1923

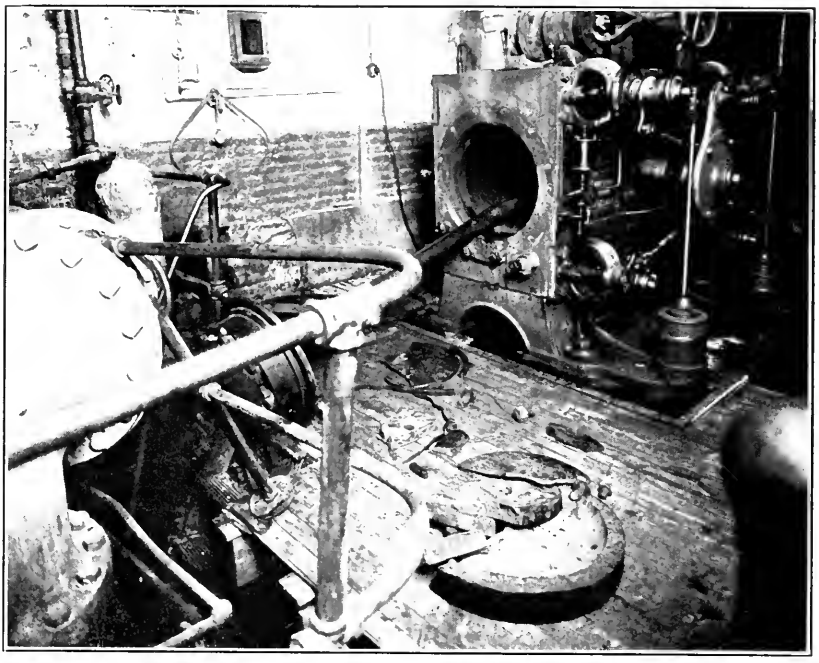
View of Wreck From Head End of Engine.

Breaking of Crosshead Gib Caused Engine Accident.

When admittance could again be had to the engine room, the cylinder-head was found blown off and lying on the floor, the piston and rod were almost completely out of the cylinder and damage seemed to prevail in all directions, as shown in the illustration above. The

An investigation was made to determine the cause of the accident and it was found that the gib which, with a cotter key, held the piston-rod in the cross head, had broken and, as this permitted the cotter or key to drop out, the piston-rod and the crosshead had become separated. Apparently this occurred shortly after the engine had passed the crank-end center so that the steam admitted to the cylinder at that time carried the piston and rod with terrific force toward the opposite end of the cylinder, breaking out the cylinder-head and causing the other damage that has been mentioned. What caused the gib to break has not been fully determined. The accident serves to illustrate however, the danger that is attendant upon the use of an engine however satisfactory its operation may appear.

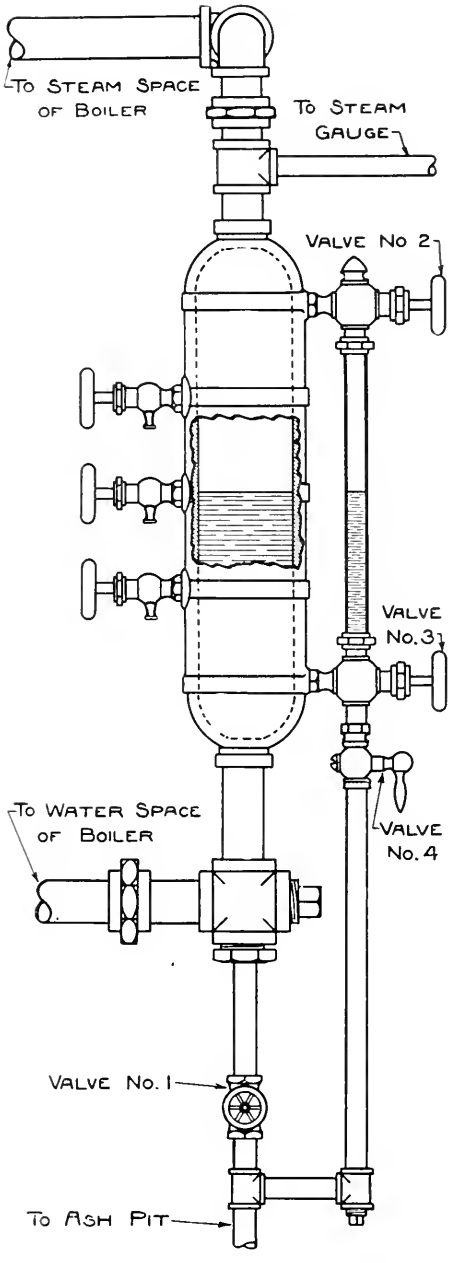
The method of piping the water column, gauge glass and try cocks to a boiler, as approved by this company, is illustrated in Fig. 1.

The connections between the boiler and the water gauge should at all times be kept free and open. Upon coming on duty and several times while on duty the fireman should blow down the water gauge piping to preclude any possibility of a stoppage in the pipe such as might be caused by scale entering it from the boiler. To do this the cocks or valves at the top (No. 2) and the bottom (No. 3) of the gauge glass are closed and the mud valve (No. 1) in the water column drain is opened and permitted to blow steam and water for a minute or two so as to thoroughly flush out the water column and the pipe connections to the boiler. After this has been done and valves 2 and 3 have again been opened, attention should be turned to the gauge glass itself. The pet cock (No. 4) should first be opened and steam and water allowed to blow through it freely for a short time. Then the top valve, No. 2, is closed to let water only pass out through the pet cock, thereby showing a clear pas-

sage to the bottom of the gauge. By closing valve 3 and opening valve 2 the passage of steam only will indicate that the top connection is clear. When this manipulation of the valves has been accomplished, the pet cock is closed and the top and bottom gauge cocks opened. If the connections are clear, the water will rise at once to the proper level where it will have a gentle up and down motion in the gauge glass. On the other hand, if the bottom connection were obstructed in any way the water would not return quickly to its proper level. If, at the same time, the top connection were open, steam would enter through it and by condensing in the glass would give a slowly rising water level. A faulty reading would also be given if the top valve were left closed after the procedure of blowing down. The vapor left in the glass would slowly condense, thereby forming a vacuum and the water, entering through the lower connection and forced by the pressure in the boiler, would rise until the glass was completely filled.

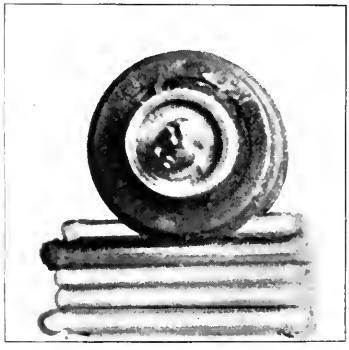
FIG. 3.

position, and the nuts or glands for compressing the gaskets should be large enough not to touch the glass when screwed up. Only fresh, pure rubber gaskets or washers cut by machine, uniform in size, and prepared for such purpose should be used. After inserting the glass in the valves, it should be shifted so the washers will be at an equal distance from its ends. This is very important, for the writer in his investigations of boiler explosions has found two instances where a washer softened by the heat, under pressure of the gland, has squeezed out under the glass and closed the opening, thus permitting a false indication of the water level. [*Editor's Note—Fig. 3 illustrates such an obstruction which recently came to the attention of the Bureau of Locomotive Inspection of the Interstate Commerce Commission.*] The glands should first be screwed by hand, each a little in turn until they can no longer be moved by the fingers. Then a small wrench may be used on them alternately, until the glass is firm in the packing. Care should be taken that the glass does not shift in its vertical position, during this operation.

"It may be needless to say that in renewing a glass with pressure on the boiler, the valves should be closed tight and the drip opened to release the pressure before attempting the removal. When a new glass has been put in, if the valves are not provided with means for opening at a distance, a board or sheet-iron shield large enough to protect one's head should be held between the face and the glass, and the valves then opened very easily and slowly to their full extent. When they are open, it is advisable to retire with the shield in front of the face to observe at a distance whether there are any leaks, and if any appear, to return to the glass with the face still protected, shut off the valves, release the pressure through the drip, and then tighten the nuts. Never under any circumstances attempt to tighten them with pressure on the glass.

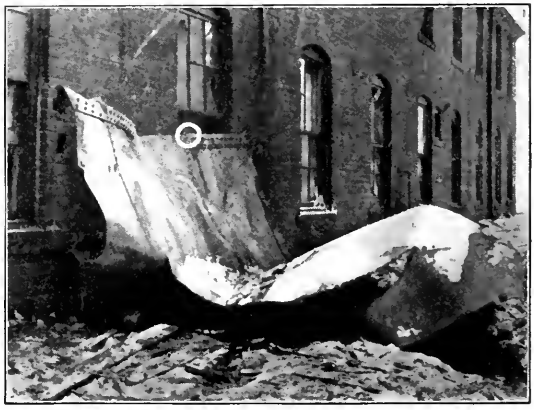
FIG. 1.

The boiler was an old one — we do not know just how old, but we believe that the age was at least twenty years — of the locomotive type and of lap seam construction. The metal was severely corroded and, worst of all, repairs had been made by autogenous welding. The owners had bought the boiler, apparently with the best of intentions, from a second hand dealer and probably this dealer sold the boiler with the belief that it was in reasonably good condition. It was said also that an inspector had passed the vessel as being acceptable for a pressure of 100 lbs. and with this belief the owners thought they had secured a bargain. Two months after the boiler was installed, however, the explosion occurred and property damage to the extent of about $8,000. was done.

the explosion occurred, the barrel-sheet of the boiler was torn off and the remainder — by far the larger part — was hurled up and against the brick wall of an adjoining building, tearing a hole in it and coming to rest in the position shown in the picture above. The barrel-sheet itself was blown up and over the remaining part of the shed and landed in an alley-way between the shed and the next building, as shown in the picture on the opposite page. Just above the third window from the left of the picture the scar may be seen where the plate first struck the brick wall.

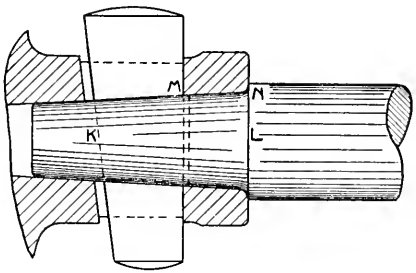
Fig. 1.

The more usual construction that is found in this type of crosshead and piston rod joint is the one in which the end of the rod is tapered, although the straight cylindrical end is sometimes used. These two variations in the general construction are illustrated in Figs. 1 and 2. The end of the rod, where it fits into the crosshead, is sometimes relieved or undercut over a length slightly greater than that taken up by the keyway. This is illustrated in Fig. 3. The cylindrical end is also made with the outer or tip section of a slightly smaller diameter than the inner section, the part between the two being undercut. It should be borne in mind, however, that any reduction in the diameter of the rod will naturally weaken it and undercutting should not be done without due consideration of this effect. Furthermore, sudden

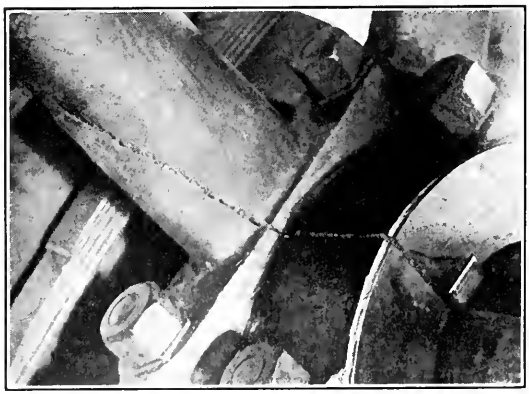
Flywheel Broken by Key.

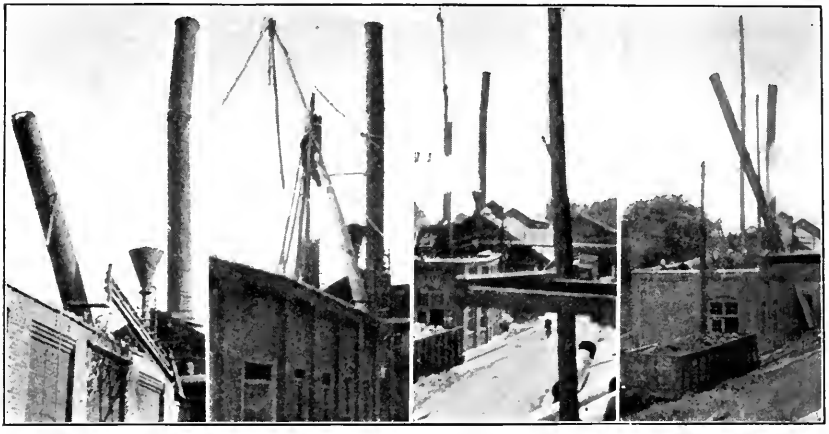
a. b. c. d.

a. Stacks Wrecked by Wind.
b. Gin Pole Being Erected.
c. Gin Pole in Place.
d. New Stack Going up.

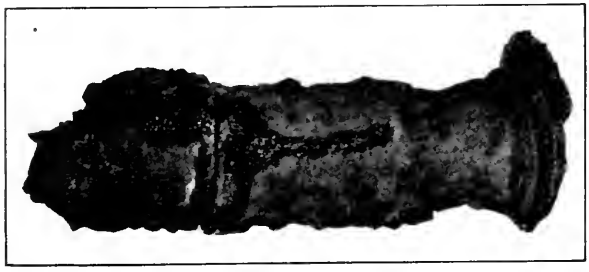
OLDE STAYBOLT.

Olde: Oh, no! Not a pound. Myself and seven of my nearby companions became reduced in body by corrosion until we were approximately 1/4 in. in diameter. And although the boiler was

nearly twenty years old, they still carried 100 lb. pressure at times, and the load of 3,000 lb. each was too much for us and when we reached our limit of resistance, we had to let go. When eight of us let go at the same time, the side sheet bulged out, pulled over the heads of many of the other bolts, then tore up along the sides and stripped loose from most of the crown bolts and ripped along one side and was blown downward. The escaping steam and hot water scalded three men, causing their death, and the force of the explosion blew the boiler in the air and about fifty yards away.

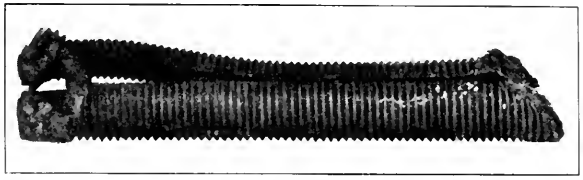
Newe Staybolt.

Newe: Well, my story is shorter than yours. My time of service was mighty short; in fact, I cannot claim to have given any service, as I was found defective before the boiler had a fire put in it. The material of which I was made was of good quality, but the heating of it was not just right, and when the round rod was rolled a portion of it was not properly welded, in other words, I was not homogenous. The imperfection did not show on the surface of the rod, and of course it got by the rolling-mill inspector. The material was compact enough to stand threading and still not show defective. Finally, I was screwed into the side of a large locomotive boiler — one end in the side sheet of the furnace, the other in the wagon top or wrapper sheet. This caused the defect in my body to become more pronounced. When the material at the ends was upset or beaded over, the shocks caused by the blows of the hammer split me practically from end to end. The separation of material was not noticeable

at the ends and while I was seriously split throughout inside the boiler, this could not be seen, and I thought I was booked to give service although defective. I missed my guess, however, as you will see. The boiler was of a standard requiring the ends of the staybolts to be drilled. So there was a 3/16 in. hole drilled in the outer end, extending 1/2 in. inside the inner surface of the outer plate. The standard specification called for a hydrostatic pressure test of 1½ times the allowable working pressure. When this test was put on the boiler, the inspector was on the job and discovered very slight leakage through the telltale hole. He ordered me taken out, and when removed I was found as you see me, split from end to end, defective, and detected by modern inspection methods. So you can see, *Olde Staybolt*, there are modern methods of making steam boilers safe.

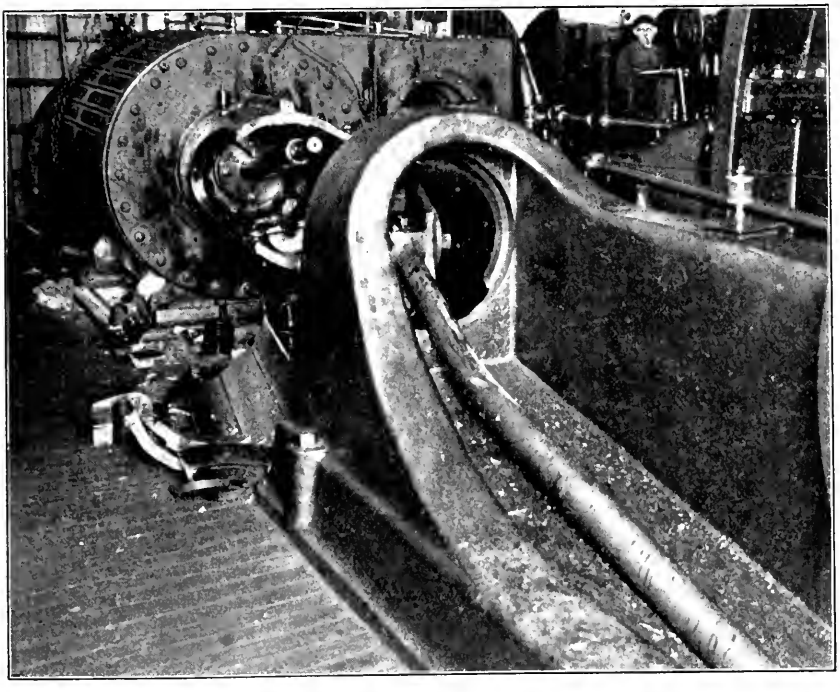
A Recent Engine Wreck.

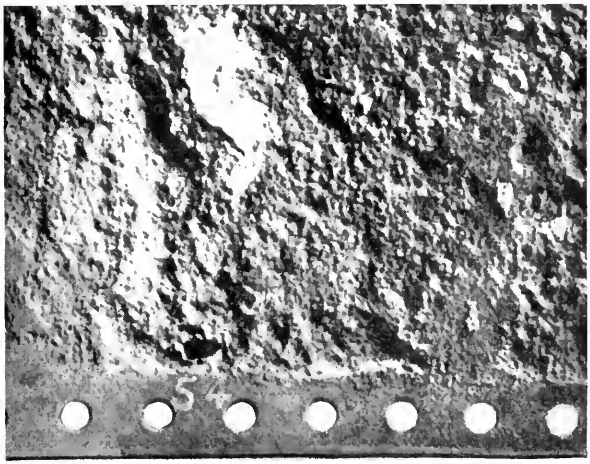
A Corroded Boiler Plate.

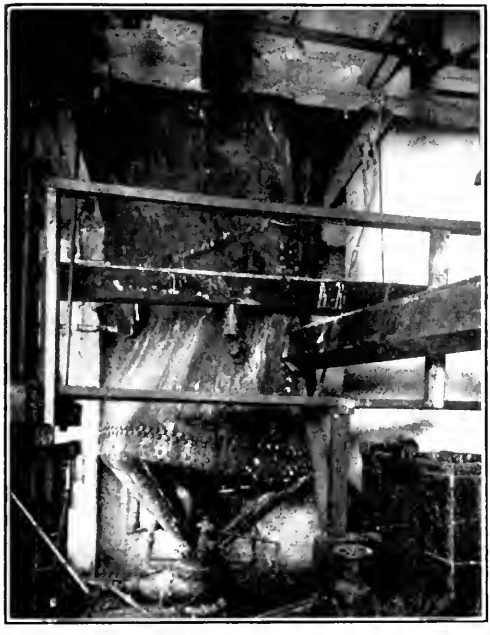
It seems that after emptying the tank, it was filled by steam and all valves closed and the condensation of this steam caused a partial vacuum that allowed the pressure of the atmosphere to exert its power on the outside of the tank shell. While theoretically a cylindrical shell ought to keep its shape when subjected to a uniform outside pressure, in actual practice, pressure on the outside surface of a cylindrical shell is almost sure to cause the failure of the same by collapse unless special bracing is provided to keep the shell in shape. A vacuum of 27 to 28 inches of mercury might be expected under the conditions outlined above and this would allow an atmospheric pressure of 13½ to 14 lbs. per square inch of area to be exerted on the outside of the shell. While it would have been safe to use three times this pressure inside the tank, it is quite evident that the tank could not stand up under atmospheric pressure on the outside without the support of some pressure inside and therefore the shell caved in at three points. The shell was so badly distorted and it had been in service for so long, that it was considered desirable to replace the tank with a new one. As this accident was due to external rather than internal pressure, the damage was not covered by the explosion insurance policy carried on the tank.

A Collapsed Cooking Tank.

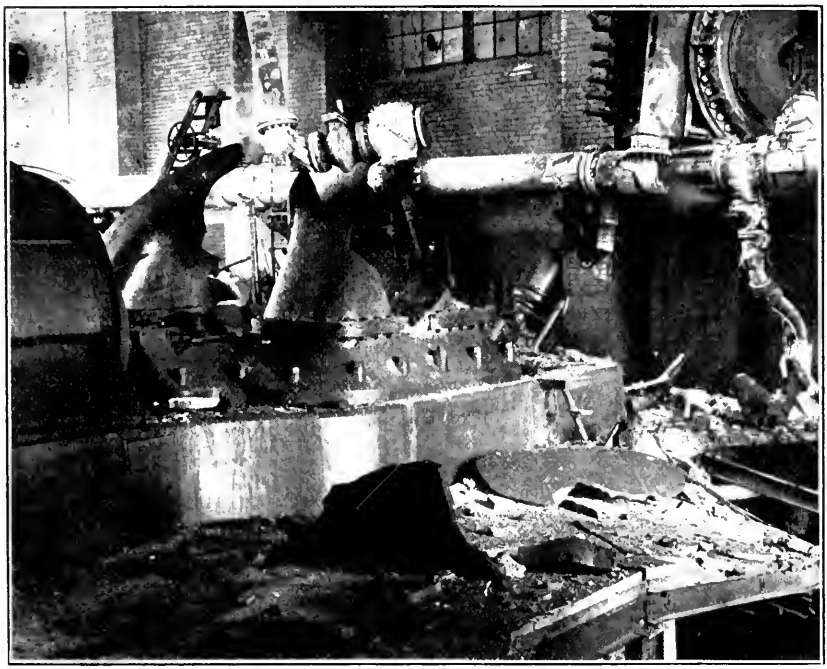
STEAM TURBINE EXPLOSION AT INDIANAPOLIS, IND.

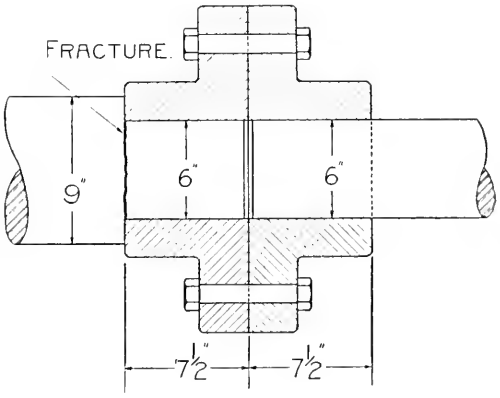
Fig. 1.

A case recently investigated by the writer was that of a broken shaft 9 inches in diameter in bearings and turned down to 6 inches diameter at one end for a length of 7½ inches. On this reduced section there was keyed a cast iron coupling to which was secured, by a number of bolts, a companion coupling which was keyed onto a 6 inch shaft of considerable length, used for transmitting power by means of a number of belt pulleys. The engine referred to is rated at 250 h. p. and was said to be developing 275 h. p. at the time the shaft broke. To illustrate the point of weakness where the fracture took place you are referred to Fig. 1 in which you will note that the 9 inch section of the shaft terminates with a sharp shoulder where it meets the part reduced to 6 inches in diameter. The distance between the surface of the 9 inch section and the surface of the

6 inch section was 1½ inches and the stresses which occurred in the cross sectional area of the 9 inch part are much less per unit of area than in that of the 6 inch diameter part because the energy transmitted is the same at all sections. In other words, we have an increase in torsional stresses at the point under discussion, which may result in the breaking down of the crystals in the material if its elastic limit is exceeded by a repetition of alternate stresses, bringing about what is known as a progressive failure.

There are three other engines at the plant where this accident took place, the shafts of which are similar to the one that broke, and it will be seen by referring to Fig. 1 that the point where the rupture took place is inaccessible for examination. Consequently a means of determining the serviceability of the shafts of the other engines at the point under suspicion had to be devised. Before doing this it had to be taken into consideration that if a flaw was found necessitating repairs similar to those outlined, no

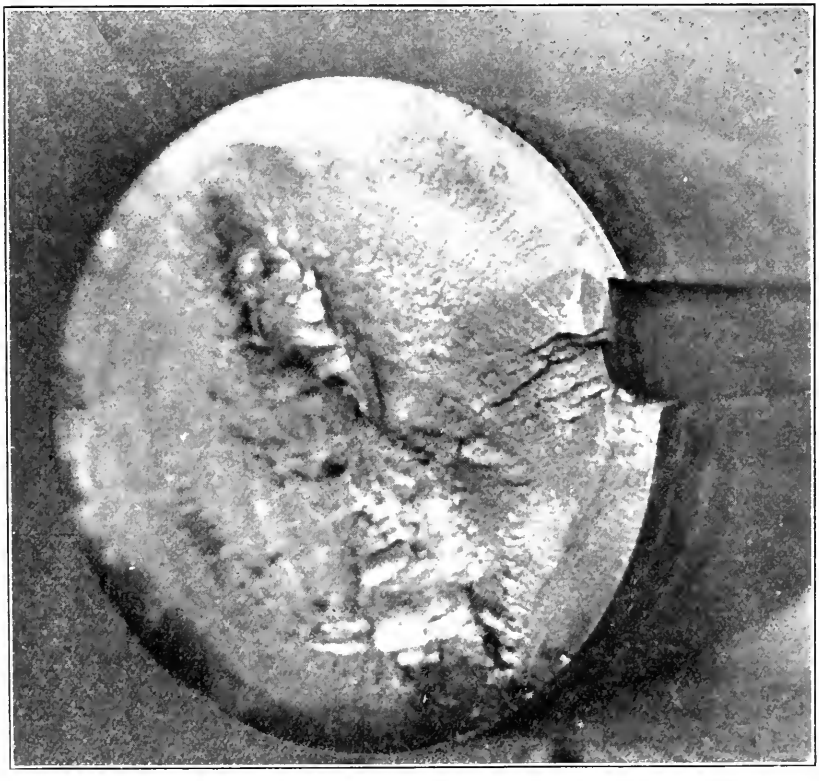
Fracture of Engine Shaft.

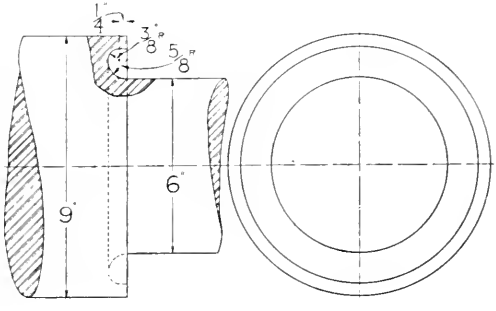
part of the limited length of the shaft from the outer side of the outboard bearing to the point where the diameters change could be sacrificed, and after considerable thought it was determined to shorten up the over-all length of the couplings by turning off the faces of the hubs 1¼ inches and forming a fillet having a radius of ⅝ inches by undercutting the 9 inch diameter section of shaft as shown in Fig. 3. This work was done with the shaft in place, an attachment for holding properly shaped tools being bolted onto the engine bed and the engine shaft allowed to revolve under its own power the required number of turns per minute to give a proper machine finish to the surfaces operated on. After this work was done a careful examination was made by means of a powerful glass and to the satisfaction of all parties interested no indication of fracture was in evidence. A further test was made by thoroughly saturating the part examined with gasolene, then drying the surfaces and coating them with a light covering of whitewash. After this had dried the engine was placed in service for a time, then shut down and careful examination of the whitened surfaces made to detect any discoloration, for had there been any fracture, which could not be seen, the gasolene having great searching properties would have entered the crack and remained therein while the shaft was in a static condition, but would have been driven to the whitened surfaces when the shaft was in rotation, thus indicating the crack. The absence of any such discoloration proved conclusively that the shafts were serviceable.

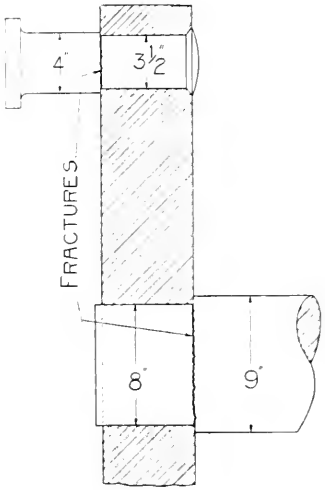
FIGURE 5.

Turning now to the consideration of a crank of the disc pattern, in which the failure of the crank pin or shaft frequently causes the wrecking of the entire engine, attention is called to the changes in diameter of the pin and shaft as shown in Fig. 5. In all cases where accidents of this kind have been noted by the writer he has found that the designer had overlooked the vital necessity of providing a fillet.

The crank pin is subject not only to slight torsional stresses, but also at the point where the diameter changes, it is subject to shearing and bending stresses. This stress is more pronounced when the pin passes through the two dead centers and is present to some extent regardless of the amount of compression provided in the cylinder.

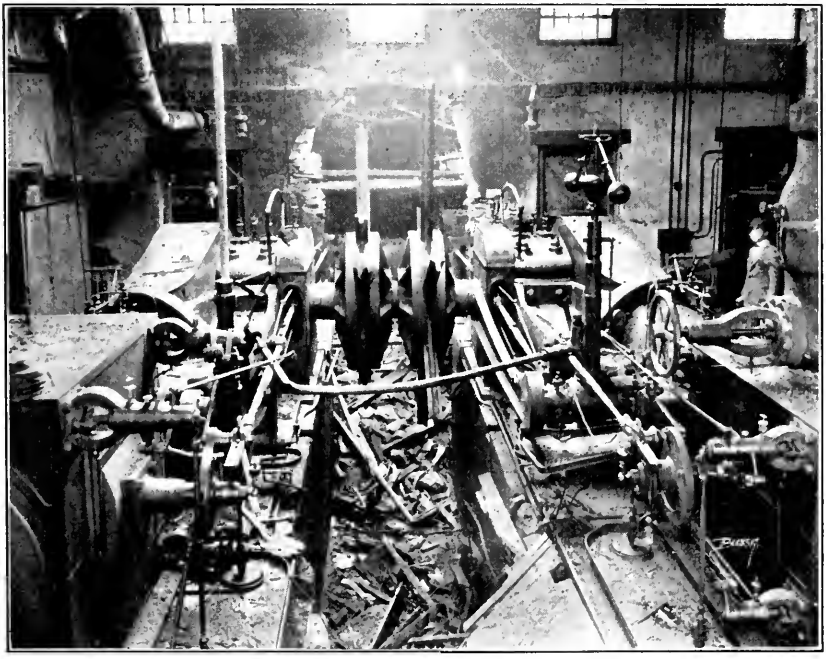
Flywheel Explosion at a Fibre Mill.

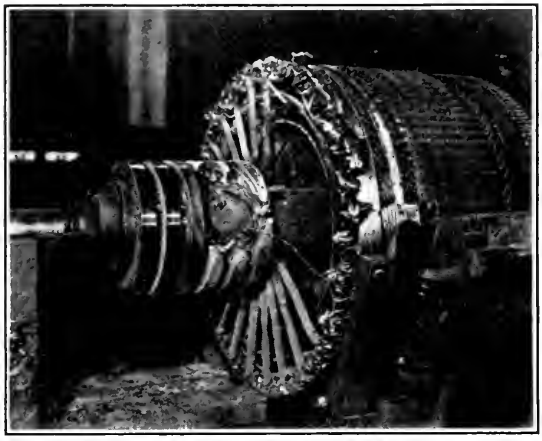
ARMATURE BURNOUT OF ROTARY CONVERTOR.

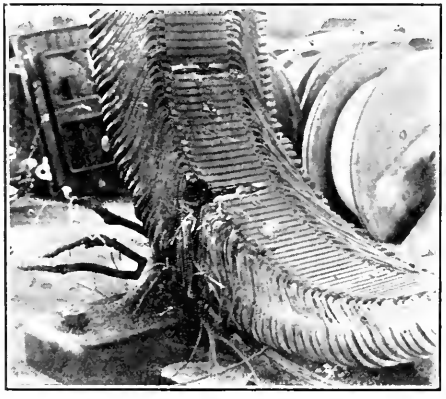
BURNOUT OF ARMATURE OF ROTARY CONVERTOR.

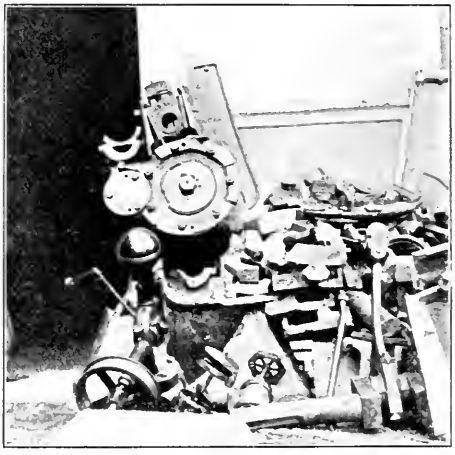
There are two kinds of throttling governors, one termed the automatic, and the second the non-automatic. The former will, and the latter will not, prevent the cylinder from obtaining steam, should the governor belt break or fall from the the governor pulley. The governor of the engine in question was of the non-automatic type, and it is possible the accident was due to the governor belt leaving the pulley, which would give the cylinder full steam pressure, and under the light load condition, would cause over-speeding, which would require but a few seconds to bring the wheel up to a disrupting speed.

REMAINS OF WRECKED ENGINE.

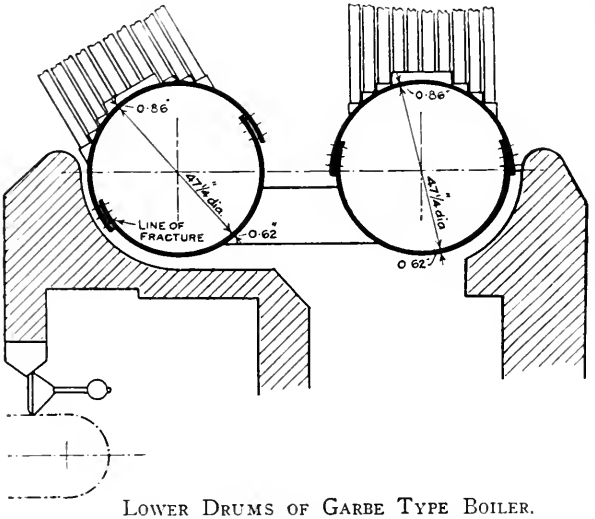
THE central station at Reisholz, situated near Dusseldorf, is one of the largest central stations of the Rhenish-Westphalian Basin. It comprises seven turbines of a total output of 73,000 kw. and 30 boilers with a total heating surface of 18,520 square metres divided into three boiler houses. In No. 3 boiler house, the most recent, there were 12 boilers of the Garbe type working at a pressure of 214 lbs. per square inch, and each having 7,104 square feet of heating surface and 215 square feet of grate area. On the 9th of March, 1920, a little after eight o'clock in the morning, one of these boilers exploded with disastrous violence, killing 27 people and injuring 14 others.

LOWER DRUMS OF GARBE TYPE BOILER.

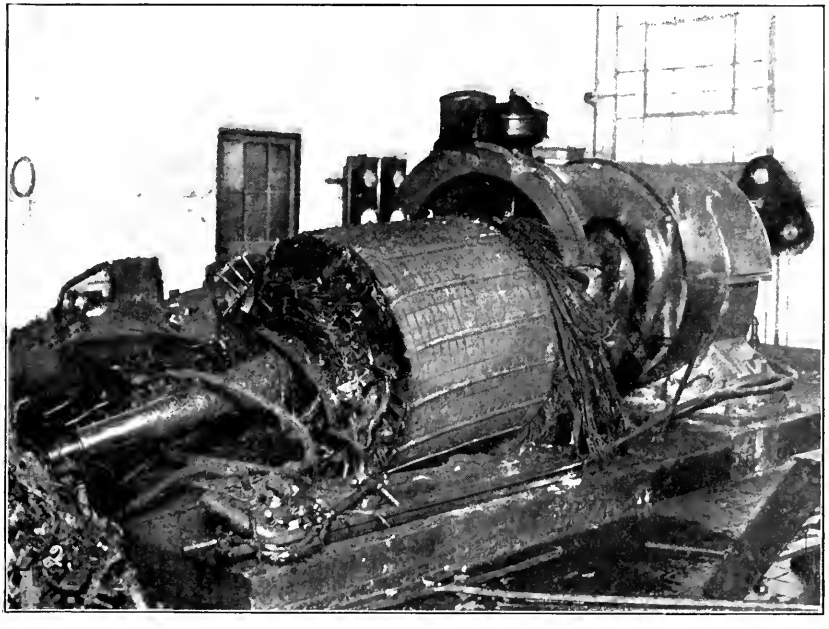
Turbo-Generator Accident at Cedar Rapids, Iowa.

A SERIOUS accident occurred at the plant of Penick & Ford, Ltd., at Cedar Rapids, Iowa, February 15, 1924, when a 2,000 k.w. turbo-generator ran away. The entire unit was wrecked and, including damage to the building and to other apparatus, the total property loss amounted to $35,000, which was covered by a Hartford policy.

The direct cause of the accident is not clear, but the evidence indicates that in some way the machine lost its electrical load. An examination of the wrecked generator failed to show any signs of burning or other electrical disturbance, it apparently being electrically dead before disruption occurred. Evidence of overspeed, however was apparent and indicated that, when the turbine lost its load, both the governor and emergency stop failed to function quickly enough and the machine "ran away," although a recent inspection had indicated that these valves were functioning properly.

The accompanying pictures show very plainly some of the unusual features of this accident. The cover page illustration is a view of the generator end of the machine and gives an idea of the completeness of the wreck. The rotor disrupted, gripped the stator windings and caused them to turn with it to a certain extent, thereby rupturing the entire generator frame. The rotor can be seen firmly wedged within the stator

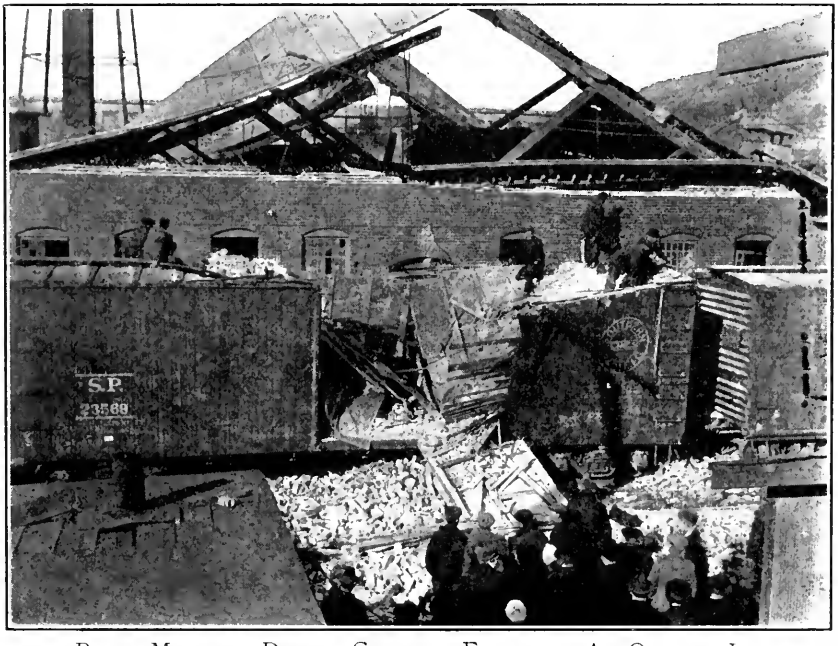
PAPER MACHINE DRYING CYLINDER EXPLOSION AT QUINCY, ILL.

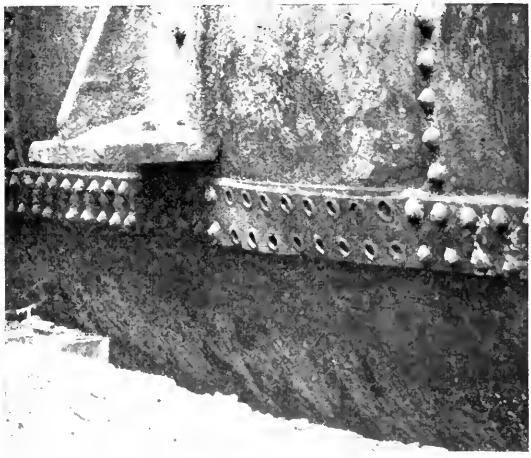
A Defective Butt Strap Discovered By Inspection.

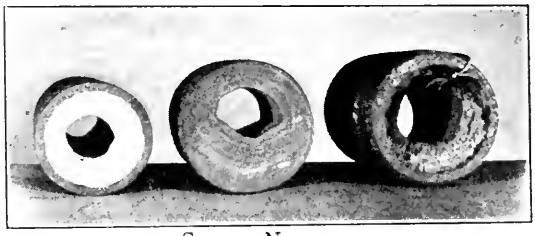
Scaled Nipples
The One On the Right Shows the Result of One Month's Run.

"The lessons to be learned from these very simple considerations are two in number. In the first place, we see that in a dry time the formation of scale is likely to go on more rapidly than usual, so that it is important to open the boilers and clean them (or at least examine them) with a correspondingly greater frequency. It is hard to say just *how much* oftener they should be opened, but it is safe to say that they should be opened at least *twice* as often as usual; a boiler that is ordinarily cleaned once a month being opened up, in a dry time, every fortnight.

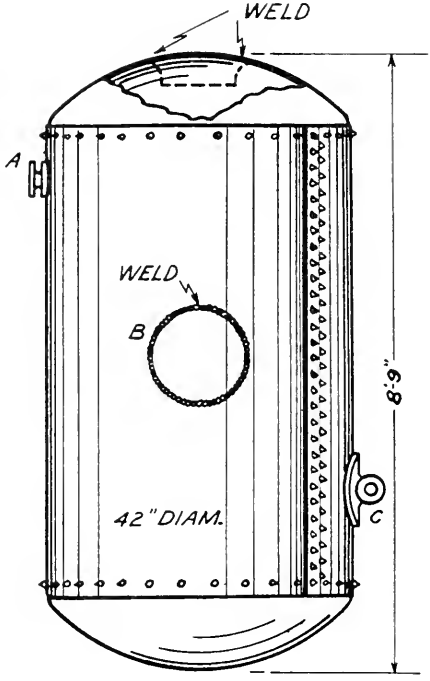
FIG. 1.

A tank of the dimensions shown in Fig. 1, formerly used as a container for compressed air and which had seen but very little service, was purchased for installation on the low pressure side of an ammonia refrigeration system of the absorption type. For some reason it was decided to remove the lower 3 inch cast iron nozzle, which was done by means of an oxy-acetylene cutting torch. A hole 10 inches in diameter in the side of the tank resulted, indicated by B in Fig 1 Into this aperture there was inserted, flush with the shell, a piece of steel plate formed to the contour of the vessel and attached to the shell of the tank by the process of electric arc welding. The manhole frame pressed in the top head had also been cut out and into the elliptical opening, 15" x 20", there had been inserted, flush with the head, a piece of steel plate fashioned to conform to the radius of the head and electrically welded to same. On completion of this work, the vessel was subjected to an air pressure test of 50 lbs. per square inch and was pronounced tight. The welder then left the premises considering his work finished.

A day or two afterwards the plant engineer subjected the tank to a further air pressure test, under which leakage was revealed in the

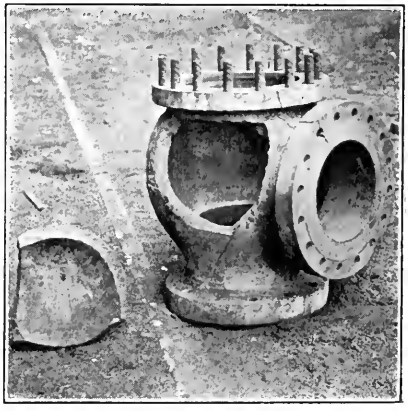
An illustration of the damage done by water hammer. In the plant where this accident happened, the fires had been banked for over the week-end, but on Sunday morning there was a sudden call for steam. The boilers were rapidly forced to meet the demand and, while doing this, water hammer developed in the main steam header. Three successive blows were delivered upon one of the stop valves which finally gave way as shown in the illustration. Fortunately, no one was injured by the accident. It was said the boiler on which the accident occurred was carrying a high water level and that the engineer was blowing down to overcome this when the rupture took place.

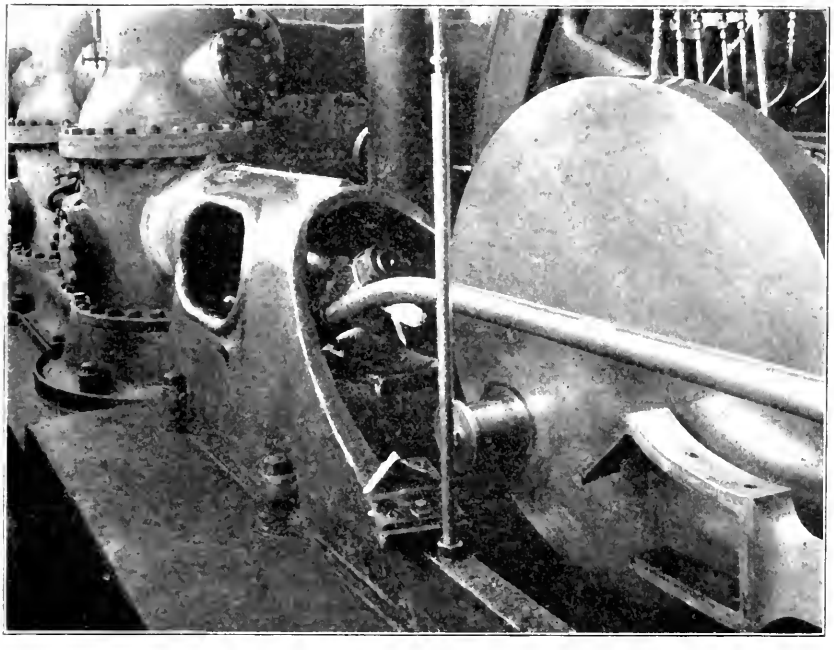
Pumping Engine Accident at Newark, Ohio.

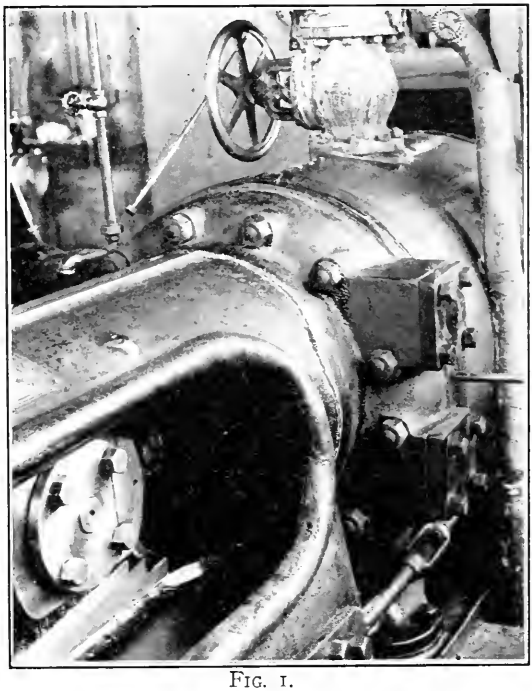
FIG. 1.

The initial break appears to have been in the strap on the crank end of the connecting rod. This break shows very clearly in the illustration on the front cover. Released from the crank, the reciprocating parts were evidently driven forcibly against the head end of the cylinder.

The most serious damage was the breaking of the main frame. This casting was 17 ft. in length, and the steam cylinder end was completely severed from the rest of the frame, as shown in Fig 1. When the cylinder moved to open up this crack, it also cracked the body of the throttle valve completely around. Besides the break in the strap, the connecting rod was bent. The piston was cracked in five places. The piston rod at the water end was broken off at the cross-head, and the cross-head itself was broken. The stuffing box gland at the water end was broken and the parallel rods, which connected the steam and water pistons, were badly bent and twisted. On account of the large

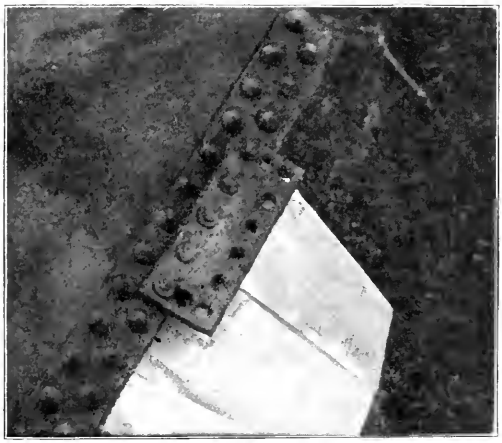
Soft Patch Used in an Unsuccessful Attempt to Repair a Longitudinal Seam Crack.

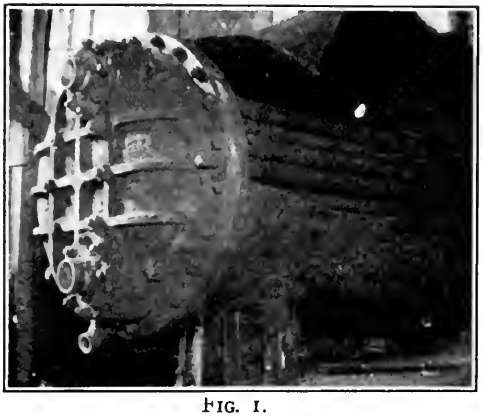
FIG. 1.

It is reported that prior to the accident the welds gave every appearance of being sound. Under but 15 lbs. pressure, however, the shell separated along the whole length of the longitudinal seam and tore loose from the end rings. Examination of the wrecked tank disclosed that the weld extended in some places to a depth of but 1/16

inch, or but ⅛ of the thickness of the plate, well showing the hazard of this type of joint.

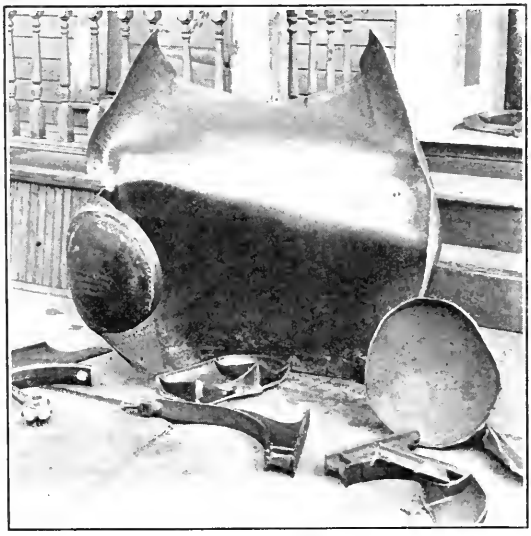
up on the outside, held the tank together. The weakest part of the weld appeared to be about 6 inches from one end, though it is difficult to say where the rupture originated as the whole weld failed, even the head girth seams. The nature of the failure is clearly shown in Fig. 3.

In connection with this accident it will not be amiss to point out the necessity for providing means for internal inspection of all pressure vessels no matter how small they may be. The poor condition of this weld would have been readily detected by such an inspection. In addition, as can be plainly seen in the picture and as indicated in Figure 2, serious corrosion had taken place forming deep grooves parallel and adjacent to the longitudinal seam. This was due to the fact that the tank was installed in a horizontal position with the seam on the bottom. If this tank had remained in use, even though the weld had been good, it is almost a foregone conclusion that it would have exploded before very long from weakness due to corrosion. Where provision is made for internal inspection, such dangerous conditions would most likely be detected and the tanks removed from service before failure.

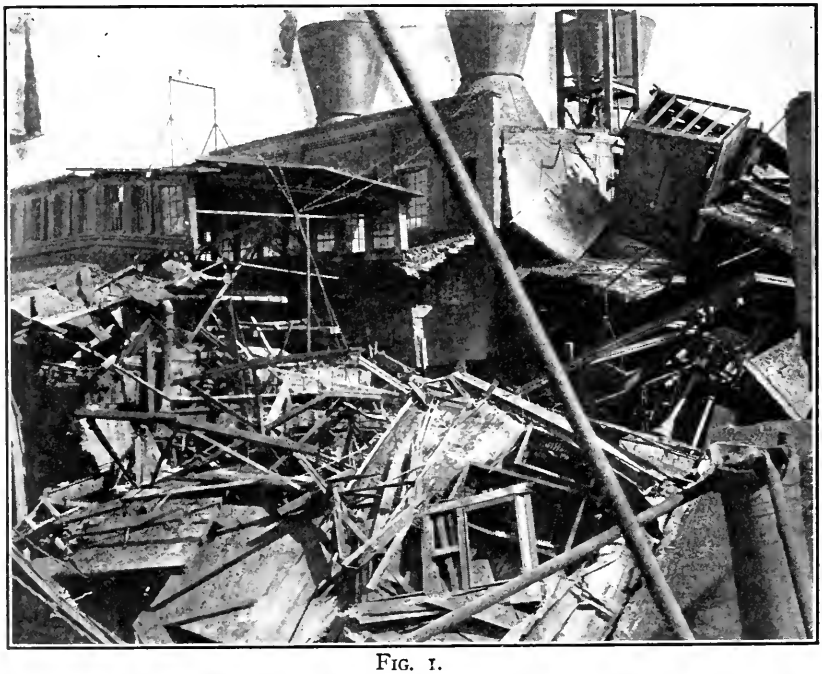
FIG. 1.

A DISASTROUS explosion occurred September 22, 1924, at the plant of the New York & Pennsylvania Company, Lock Haven, Pa. One of the sulphate digesters exploded, killing three employees and injuring four others, and resulted in a property loss of $150,000. There is no picture available showing all of the wrecked area, but the view on the cover and also Fig. 1, both taken from within the digester room, show a portion of the wreckage.

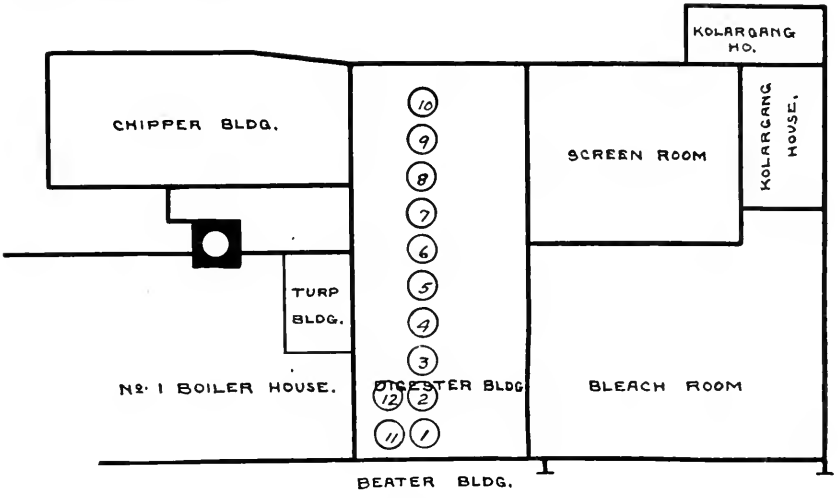
FIG. 2.

The digester that exploded was No. 7 of a battery of twelve arranged as shown in the plan in Fig. 2. All of them were either blown from their foundations and lying down or else in such dangerous positions that they had to be removed. The digester building was a complete wreck and parts of adjacent buildings were damaged. In accidents such as this one, flying pieces of wreckage usually do considerable damage at places quite remote from the scene. In this instance, however, the damage, though severe, was restricted to the comparatively small area in the immediate vicinity of the digester building. A heavy reinforced concrete charging floor near the top of the vessel undoubtedly exerted a smothering effect.

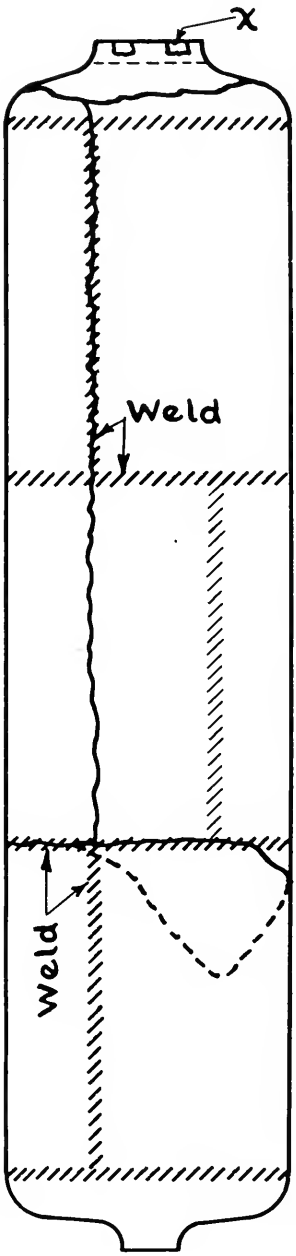
FIG. 3.

at the first girth seam. The middle and top courses were torn across longitudinally and opened out flat. The top head blew out and in addition the manhole ring in the top head also went out by itself. As will be noted, the break seems to have followed the welds to a considerable extent and, from the character of the rupture, it would appear as if the explosion resulted from the weakening of an imperfectly welded joint by the gradual thinning of the vessel.

Because of the peculiar nature of the break there is some difference of opinion as to just where the initial failure occurred, that is, whether the upper head failed first or the lower portion of the shell. The indications point more strongly toward the latter. For about one-third of the distance around the lower seam there appears to have been very little of the metal actually joined in the weld and the two pieces of metal slipped apart at the scarfed joint with very little tearing. The only portions of the defective part of this joint that appear to have been thoroughly welded are at the edges of the scarf, as indicated by the line of rupture in Fig. 4A. Furthermore, in places the portion of the joint between *a* and *b* showed a polished appearance as if a small amount of movement had been taking place there for a considerable period of time. The wasting away of the interior of the digester removed part of the metal from the sound portion of the joint and thus seriously weakened it. Additional evidence that the initial break occurred here is given by the fact that the side of the shell opposite to the rupture caved in, apparently as the result of the

bending back of the lower course at this seam. Also the failure of the explosion to be widespread in effect, as previously mentioned, would indicate the initial failure to have been near the bottom of the vessel.

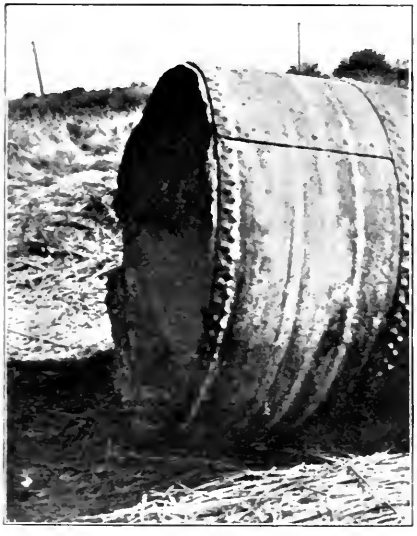
Fig. 3.

The initial failure was in one of the heads and an examination of the torn plate reveals the cause of the explosion. The rupture clearly shows that a crack ran for a considerable distance along the bend of the flange, and the indications are that this crack had existed for some time. Serious external corrosion had taken place and perceptibly thinned both the shell and the heads. Thus weakened, the head plates probably underwent a slight expansion and contraction, or "breathing," as the vessel was alternately under pressure and released from pressure. The result would be a continual bending action at the turn of the flange, and finally a cracked head.

The shell of the boiler came out of the accident almost unscathed, but the opposite head suffered some damage, a large piece having been knocked out, most likely by collision with some other object.

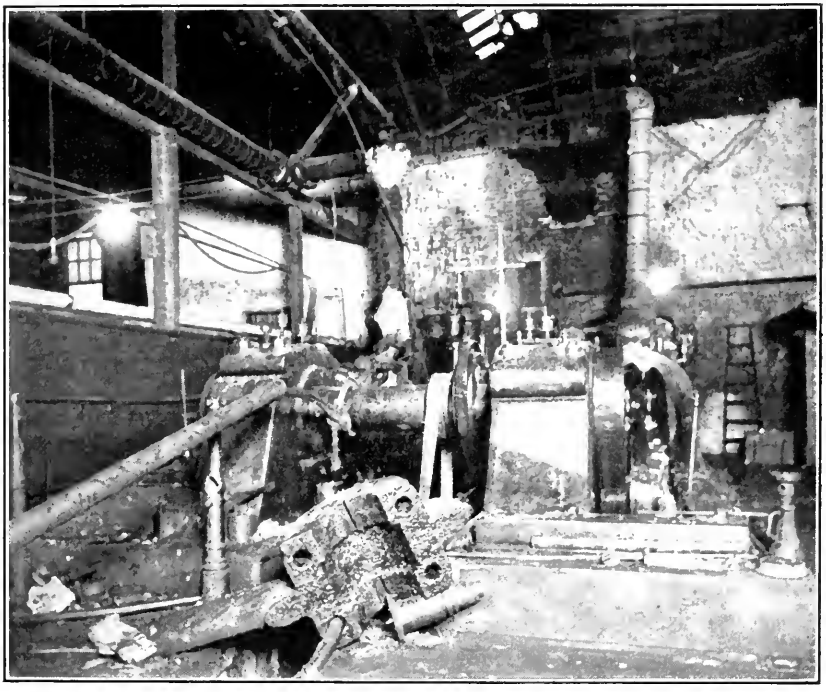
FIG. 1.

Another flywheel explosion, also resulting from a slipping governor belt and shown in Fig. 1, occurred July 18, 1924, at the Greenville Ice &

Fuel Company's plant of the Carolina Public Service Corporation. The suction valve pocket on an ammonia compressor failed and allowed the valve to drop into the compressor cylinder. The cylinder head was knocked out and the ammonia thus released. The engineer advanced toward the throttle spraying water from a hose into the fumes, and inadvertently wetted the governor belt. The engine immediately speeded to destruction.

The wrecked wheel was part of a 75 ton ice machine and was 16 ft. in diameter and weighed 18 tons. Pieces of it traveled over 300 ft. wrecking, amongst other things, the 10 ft. flywheel on another ice machine, several 12 inch x 12 inch reinforced concrete supports for the condenser tower, as well as some motors, piping, and other equipment.

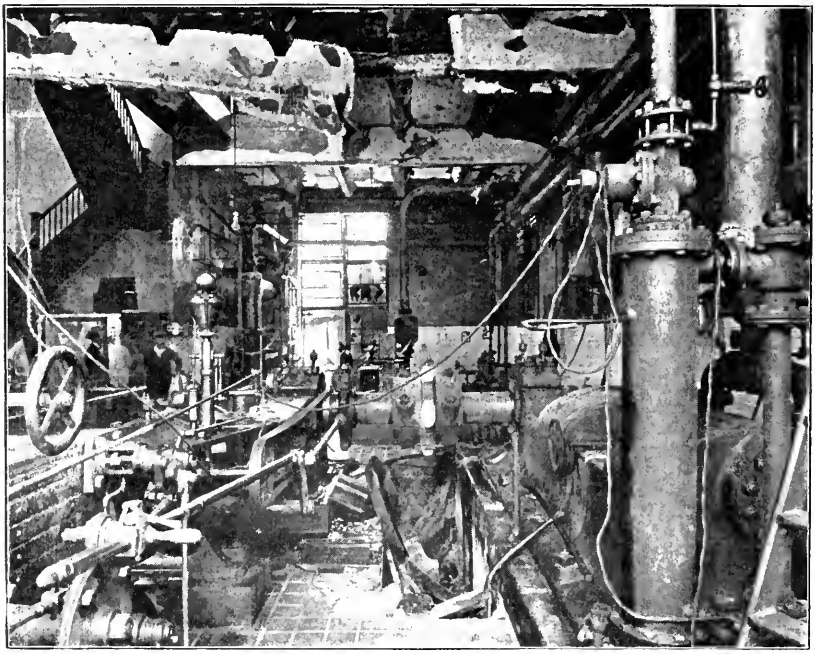
FIG. 2.

The results of still a third accident, the cause of which is also said to have been the failure of the governor belt, are shown in Fig. 2.

This was a 12 ft. flywheel and normally operated at 58 r.p.m. The immediate cause of the engine over-speeding is not apparent, but an examination after the accident revealed that the governor belt was not in good operating condition and undoubtedly ran off of the governor pulley. The belt was oily and slack on the pulleys. In addition, one

edge rubbed hard against the engine frame as shown by the worn condition of the edge.

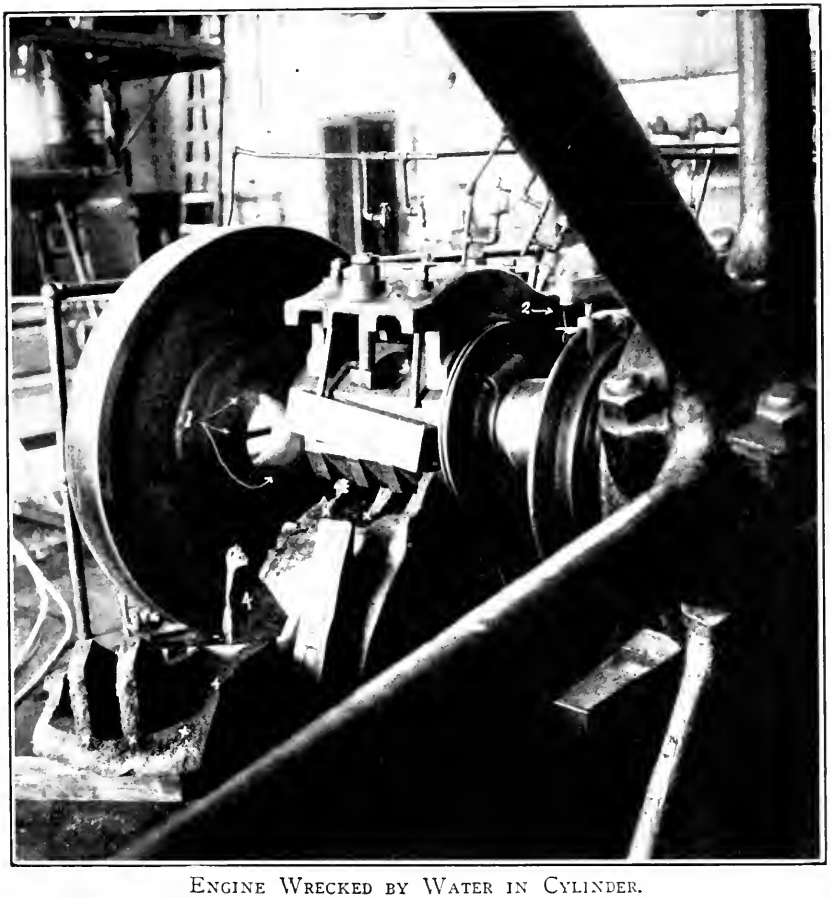
ENGINE WRECKED BY WATER IN CYLINDER.

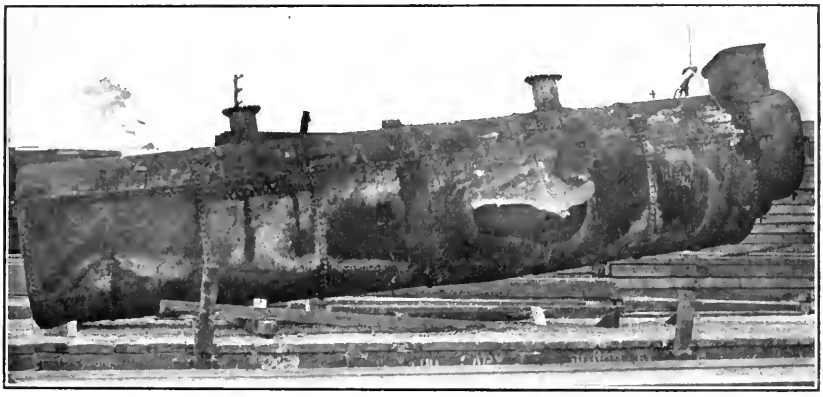
Boiler Burned and Ruptured as a Result of Low Water.
The Blow-Off on This Boiler Was Found Open When the Debris Was Being Cleared Away After the Accident.
